Manhole Inspection Summary

Manhole # S37EE1022MH

Location Address: **3717 GREENMOUNT AVE**

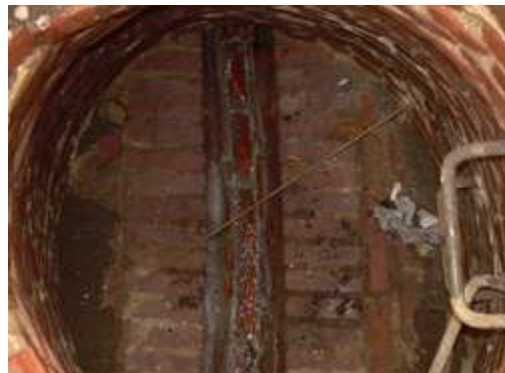
Top View

Infiltration: ☐ None ☒ **Joint** ☐ Cracks ☐ Mortar ☐ Roots ☒ **Wall**

Surcharge ☒ **Evidence Of Surcharge** Depth: **1** (ft.) ☐ Active Surcharge Present

Corbel infiltration. Evidence of surcharge - Bench debris.

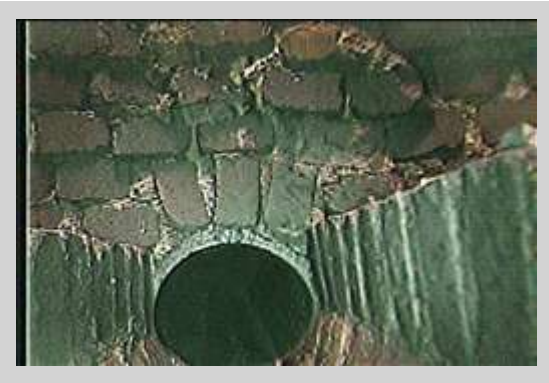
8 in. Circular Gravity Sewer Pipe Out @ 12 O'Clock

Condition: ☐ Sound ☐ Cracked ☐ Root Intrusion ☐ Loose Brick ☒ **Deteriorated**

Infiltration: ☐ None ☐ Joint ☐ Cracks ☒ **Mortar** ☐ Roots ☒ **Wall**

Condition: ☐ Sound ☐ Cracked ☐ Root Intrusion ☒ **Deteriorated** ☐ Leaks ☐ Debris

Barrel deterioration and infiltration. Channel deterioration.

Infiltration: **Evidence** Pipe Seal Cond: **Unknown**

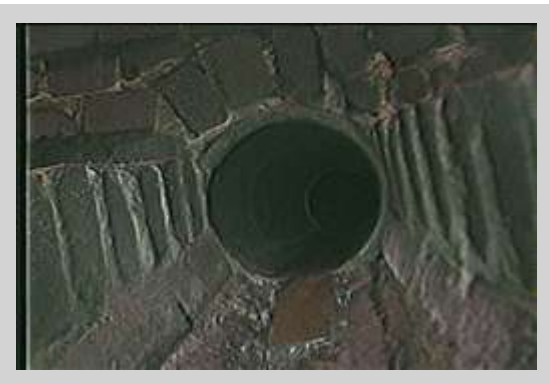
8 in. Circular Gravity Sewer Pipe In @ 6 O'Clock

Barrel deterioration and infiltration.
